Streaks in Polished Concrete Slab

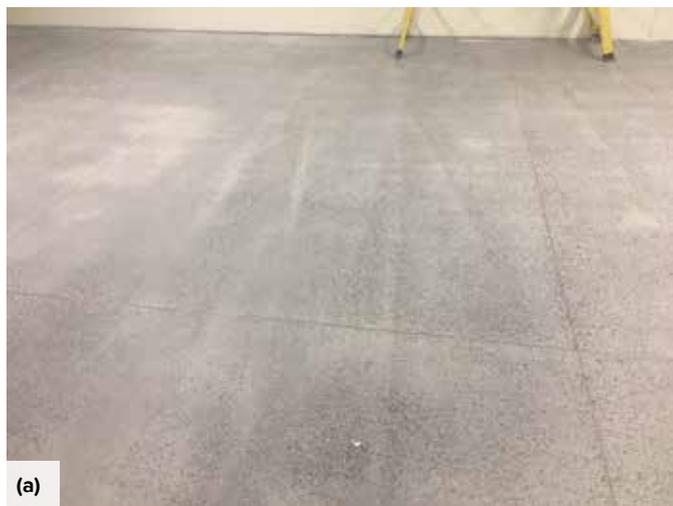
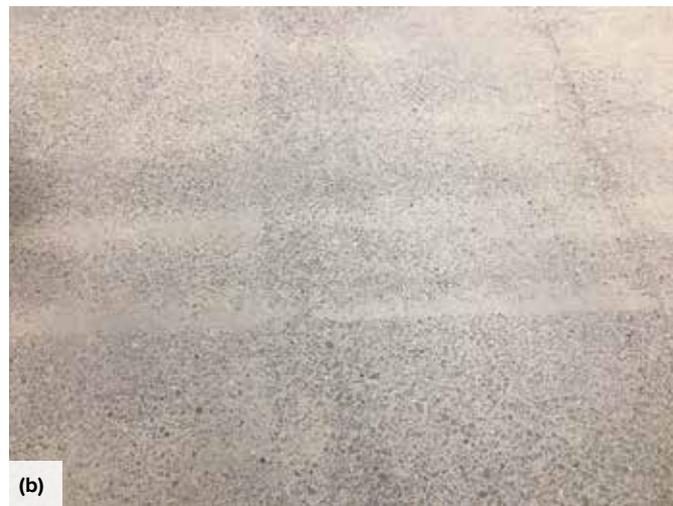
Cream (paste) streaks in a polished concrete slab placed with wheel-mounted laser-guided screed: (a) general view; and (b) a close-up

Photos included in this Q&A show cream streaks that are not consistent with reinforcing bar spacing, footprints, or tire locations. The cream streaks appear to be the size of a vibrating head for a smaller laser-guided screed, as the locations are not consistent. It also appears that short pulls were made with multiple touchdowns or that the position of the vibrating head was paused while concrete was raked or pushed to an appropriate height.

In your case, it appears that the laser-guided screed was a primary contributor to the streaking. If a vibrating screed is moved at a steady rate across a slab, the aggregate will generally be displaced a consistent depth and the cream (paste) will be brought to the top uniformly. However, the aggregate won't be uniformly distributed at locations where the vibrating head first contacts the concrete surface (touchdown locations) or where the head was stopped or slowed.

To minimize the appearance of cream streaks like those shown in the photos, the polisher will need to grind deeper to expose the aggregate beneath the cream. This will require more grinding than planned by the polisher. Also, because the aggregate color will become more dominant, it may result in an appearance that the owner finds unacceptable.

In general, cream streaks from a laser-guided screed can be minimized with soft touchdowns and consistent pulls. Head variables such as angle of attack, vibration frequency, and

intensity can also affect performance, so consider contacting your screed manufacturer for more information regarding equipment settings and operation when concrete is to be polished.
