# Concrete Trails

National Concrete Pavement  
Technology Center

AUGUST 2019

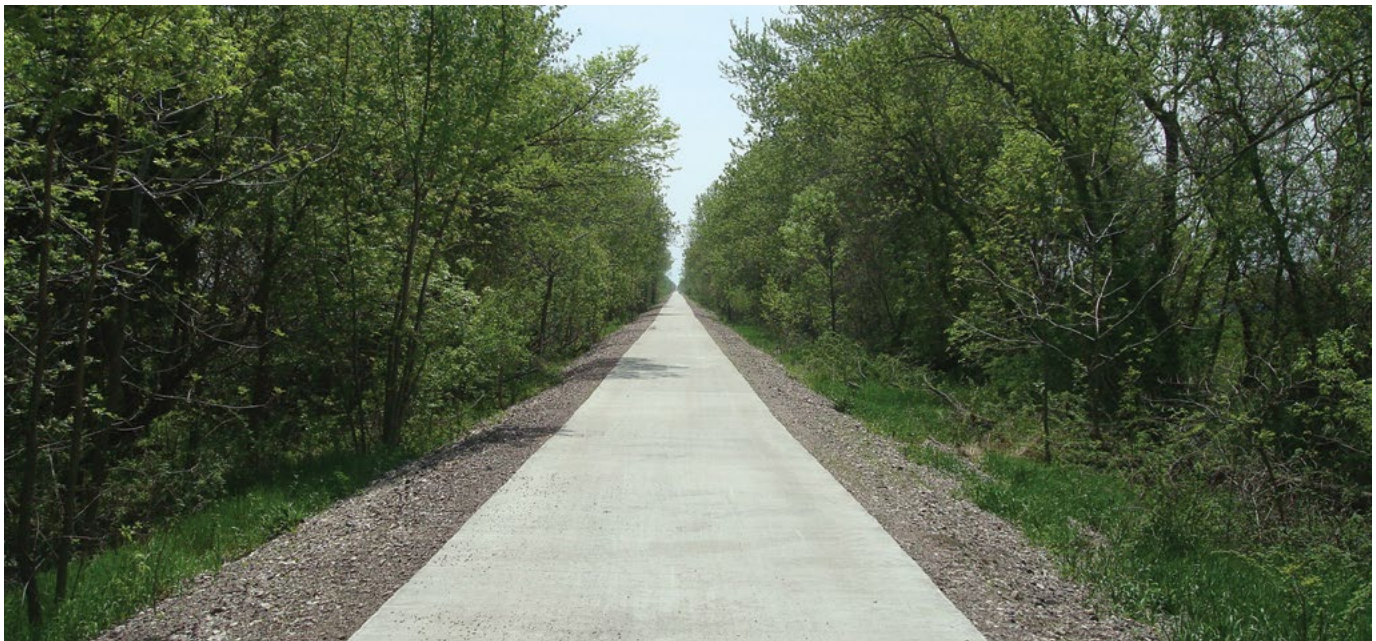
**Figure 7. Former railroad converted into trail**

The Staggers Rail Act of 1980 allowed the discontinuation of unprofitable rail routes. Struggling railroad companies then began abandoning 4,000 to 8,000 mi of rail lines each year. In response, Congress amended the National Trails System Act to allow railbanking, which permits a trail agency to contract with a railroad company to lease-purchase an unused rail corridor. Railbanking is a preabandonment procedure that prevents the railroad resource from being lost or removed (Figure 7). Since the railroad corridor is not officially abandoned, the lease-purchase agreement between the railroad and the trail agency preserves the railroad's right to the corridor should they decide to resume service on that line in the future.

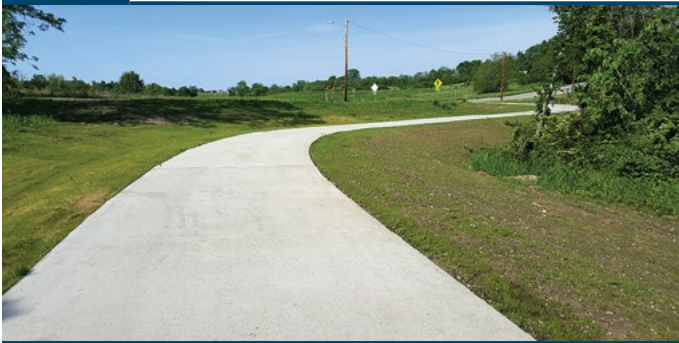
New

Constructed in 2018

Concrete can be competitive in most markets. When designed and constructed properly, it is not uncommon for a concrete trail to be in service for over 30 years while maintaining a good overall pavement condition. The maintenance activities performed over this lifespan are simple, low in cost, and can be performed by local-agency labor with local materials. Figure 9 illustrates the condition of existing concrete trails at different ages.

Figure 9. Concrete trail conditions over time

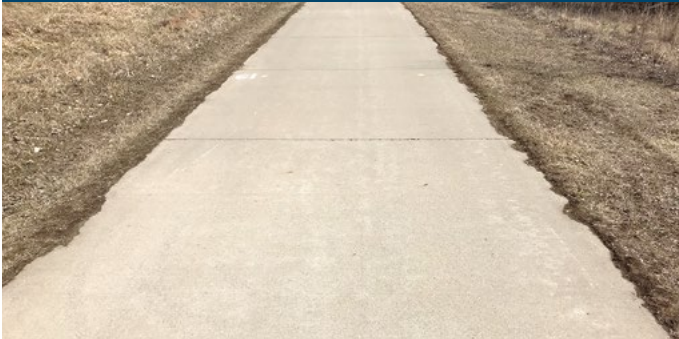
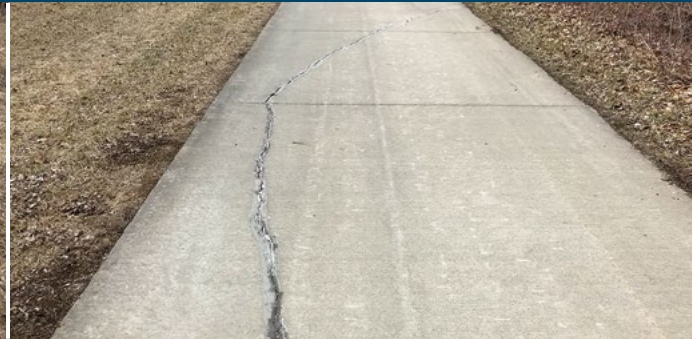
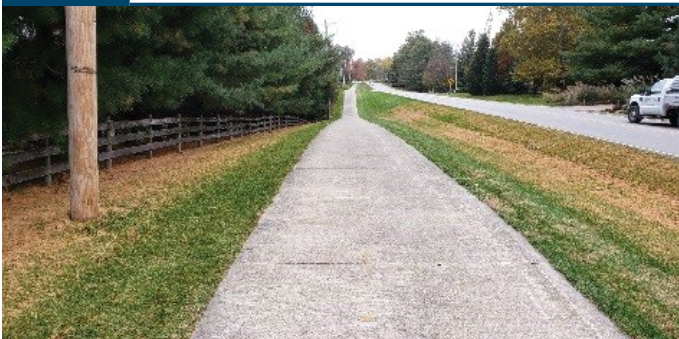
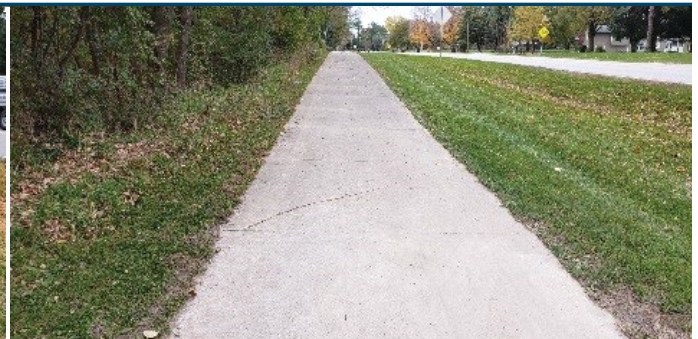
Good condition for 99% of the trail length—Constructed in 2008

Fair condition for 1% of the trail length—Constructed in 2008

Good condition for 95% of the trail length—Constructed in 1998

Fair condition for 5% of the trail length—Constructed in 1998

Good condition for 90% of the trail length—Constructed in 1988

Fair condition for 10% of the trail length—Constructed in 1988

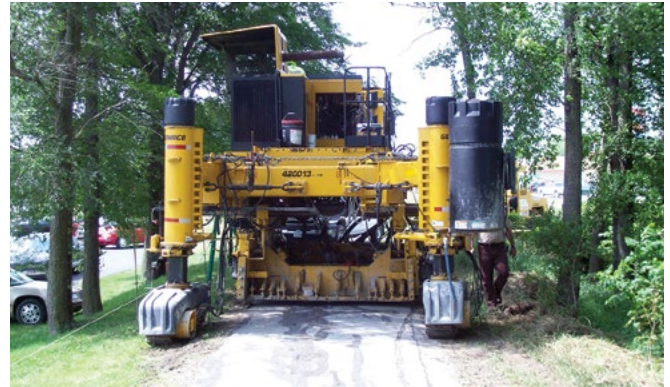
**Figure 14. Concrete overlay on asphalt trail**

Concrete overlays on existing asphalt trails can be a successful method of major rehabilitation. Properly designed and constructed concrete overlays on roadways have performed for 20 years or more without further major rehabilitation (Gross et al. 2017). The *Guide to Concrete Overlays of Asphalt Parking Lots* (Harrington et al. 2012) can be referred to for design consideration on trail applications. Figure 14 shows a concrete overlay constructed over an existing distressed asphalt trail in Guthrie County, Iowa.

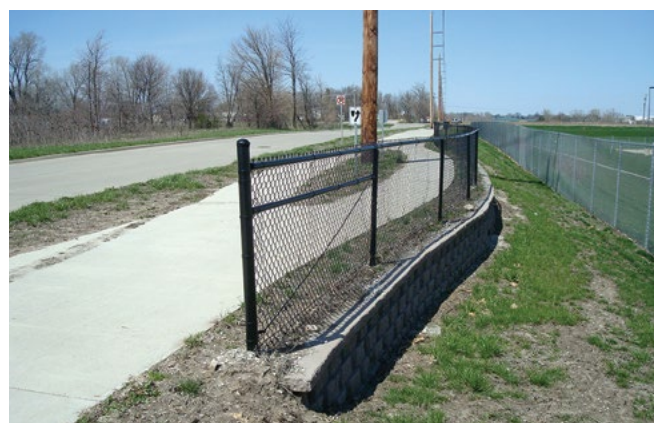
**Figure 16. Barrier along the trail installed for safety**

Separation of the trails from other natural and artificial structures should be provided for the safety and comfort of the users. To separate the trail from obstacles like trees, rocks, bridge piers, poles, and abutments, a minimum of 2 ft graded area with a maximum cross slope of 6:1 should be maintained. If a trail runs alongside a roadway and the offset from the curb edge is less than 5 ft, or the trail runs alongside a water body or downward slope of 3:1 or steeper and less than 5 ft of separation is present, then a safety barrier or railing is needed (Figure 16). The railings should be at least 42 in. high. A minimum vertical clearance of 10 ft is typical for tunnels, under-bridge crossings, as well as other overhead obstructions.

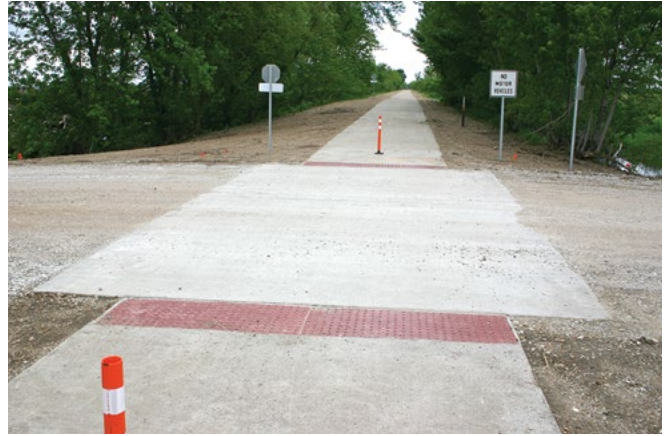
Figure 17. Paved crossings of gravel roads

Gravel road crossings (and field entrance crossings) should be paved to reduce trail user accidents due to the change of surface materials and potential windrows of loose material at the roadway edges (Figure 17). The paved crossing can have either curved or squared off headers, as preferred by the jurisdiction that maintains the roadway.

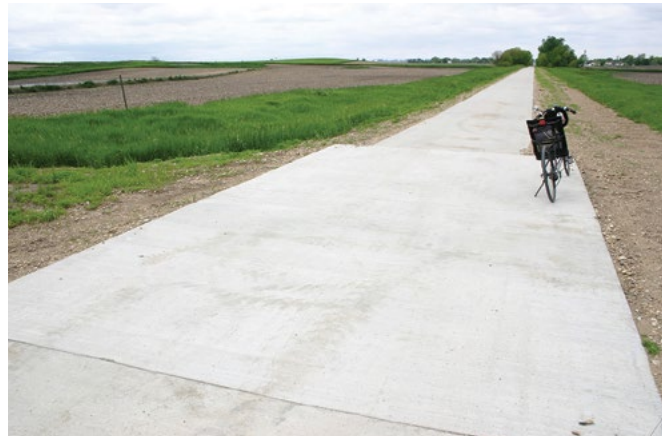
Figure 18. Thickened/widened section on field entrance crossings

A thickened section is recommended to withstand heavier loading from vehicles or farm equipment at trail crossings of roadways or field entrances. Crossings that carry traffic should be designed similar to a paved roadway thickness to follow local jurisdictional specifications. These crossings can be placed during the construction of the main trail or completed later by hand placement.

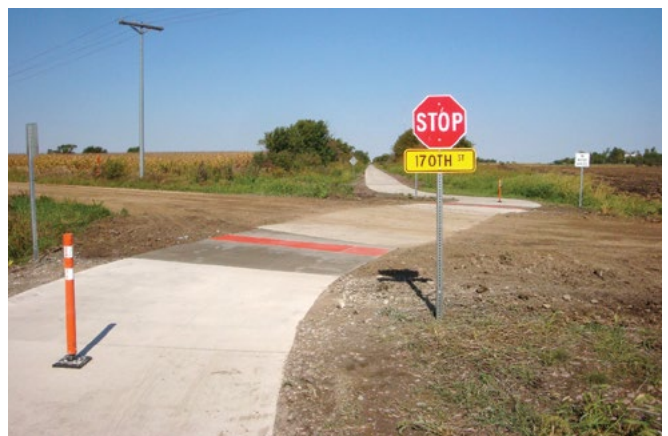
Figure 19. Sign and bollard installed at intersection/crossing

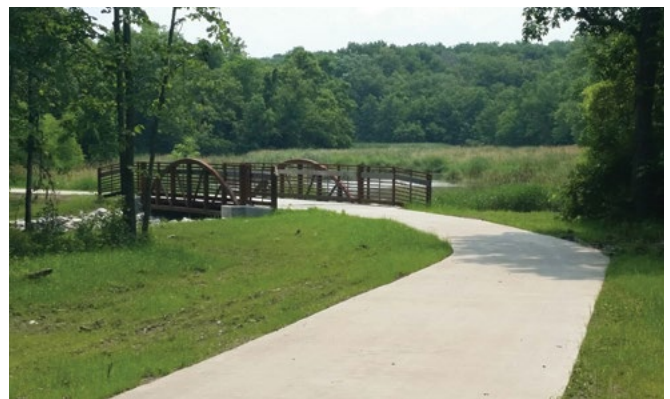
Figure 23. Pedestrian bridge over a stream

Paving equipment crossing shallow culverts can easily disturb the base material and potentially cause failure of the culvert. Heavy loading should be avoided if there is a potential for collapse of the culvert. Heavy loading may also be from delivery of concrete in trucks utilizing the trail bed as a supply route. Low-load paving methods (e.g., fixed form, extension screeds, truss screeds) may be the most effective methods of paving for sections extending over these shallow structures.

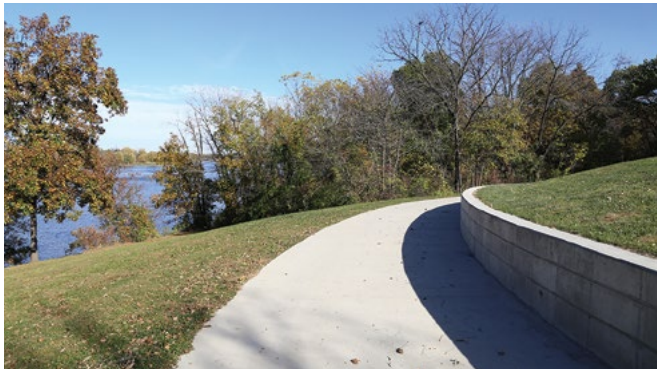
**Figure 25. Combined retaining wall and trail**

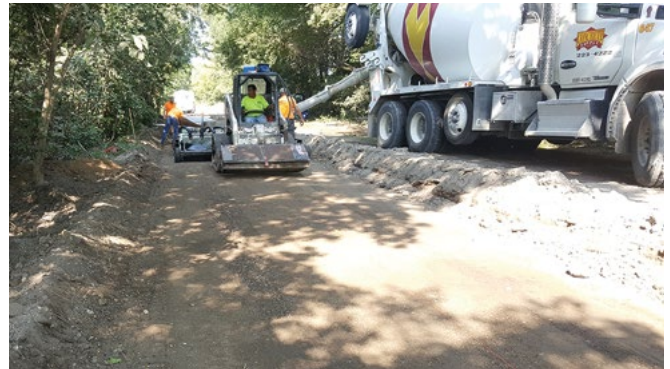
**Figure 26. Concrete trail construction**

Paving operations can complicate staging plans due to the limitations of the equipment, construction limits, and cure time for pavement. Concrete paving starting at bridge structures and directed outward tends to be more effective than paving towards bridge structures, unless the structure is wide enough and capable of handling the loading.

Construction planning and project design should include consideration for stockpiling of shoulder material along the edge of the corridor in regular intervals prior to paving. This will avoid the need of hauling shoulder material on a recently placed trail pavement. The staging areas can also be used as turnarounds for concrete delivery.

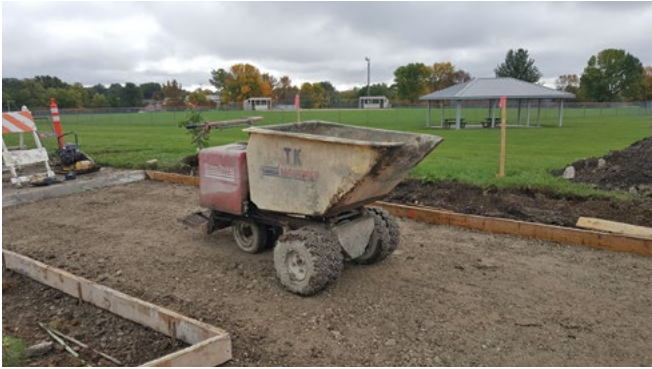
**Figure 27. Buggies provide efficient concrete delivery**

Restrictive corridors, narrow bridges, and subgrades that are not suitable for loaded concrete trucks require an alternative method of concrete delivery. Buggies, as shown in Figure 27, can navigate efficiently along the proposed trail alignment without disrupting the compacted subgrade. They are also able to turn around easily and maneuver for loading and unloading.

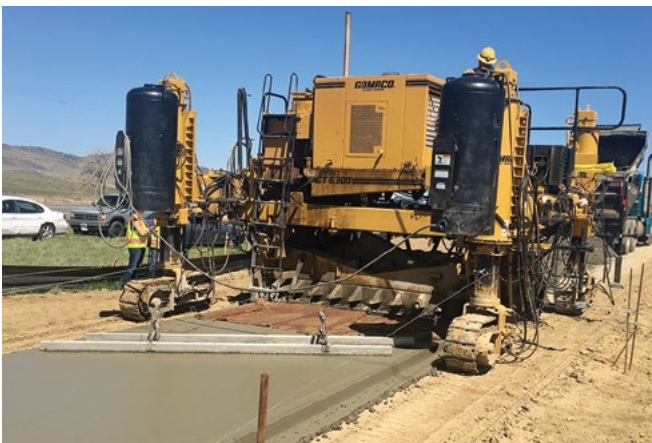
**Figure 28. Slipform paving produces trails of uniform thickness and width**

Slipform paving is a concrete placement method where a paving machine uses vibration to spread and consolidate the material onto the grade without the use of side forms (Figure 28). With this method, the concrete mix is designed such that the material holds a vertical edge without slumping. The use of slipform paving equipment is becoming more common for concrete trails. Some agencies require the use of slipform paving for trails over 200 ft in length.

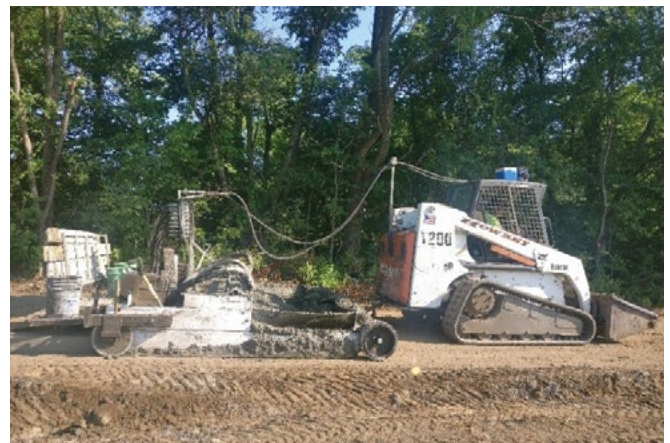
**Figure 29. Skid-loader-pulled box paver**

Use of a box paver requires the subgrade to be stable and finely trimmed to grade because there is typically no traditional stringline for elevation control. Similar to a traditional slipform paver, a box paver is equipped with a hydraulic vibration system to assure concrete consolidation. The hydraulic manifold block on the paver allows control of the vibration frequency of each vibrating device.

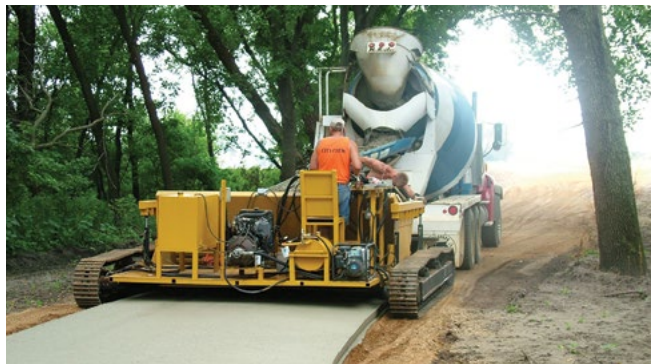
**Figure 30. Track-driven box paver**

Concrete is dumped into the box paver behind the skid steer alternately from the left and right sides via a buggy to make sure that concrete is spread evenly since there is no auger for even distribution. The simplicity of the equipment makes it very quick and easy to clean and mobilize. Figure 30 shows a track-driven box paver.

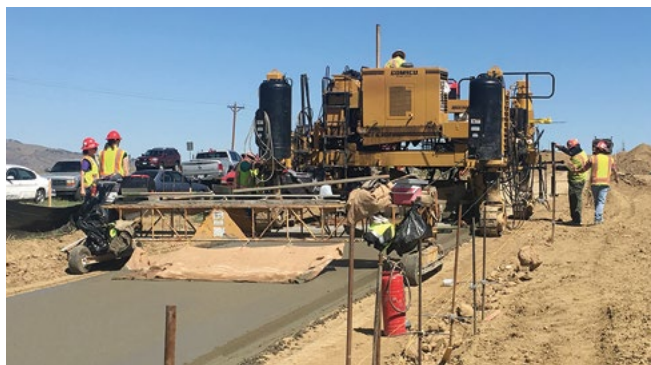
**Figure 31. Burlap attached to paving machine**

Wet burlap can be used for finishing and texturing the trail surface. Burlap that covers the trail width is attached to the back of a paving machine or screed and is dragged along to create the textured surface. It can also be dragged manually by two people on either side of the trail. The texturing should be completed once the concrete is sufficiently set and without the presence of bleed water (Figures 31 and 32).

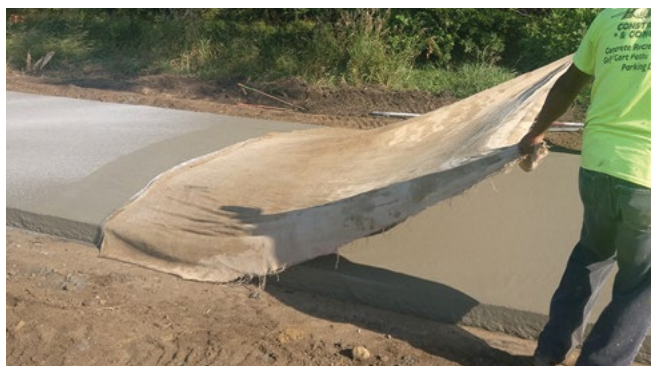
**Figure 32. Manual burlap drag finish**

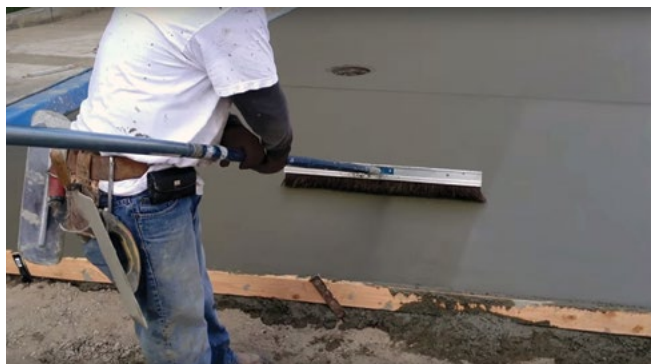
**Figure 33. Broom finish**

A broom can be used for texturing the concrete surface by dragging it in the transverse direction (Figure 33). Brooming helps create a slightly roughened surface with a uniform appearance, thus increasing surface friction. A proper and uniform surface texture helps prevent slick areas during wet weather.

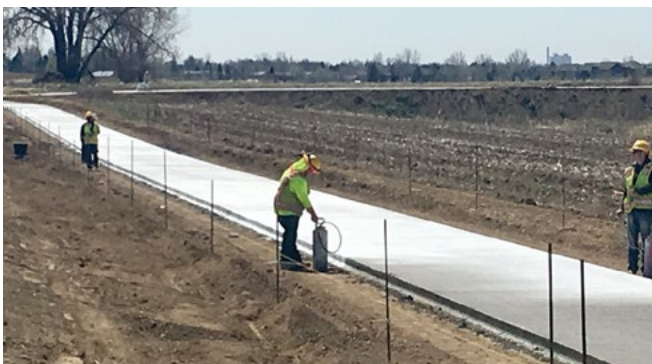
**Figure 34. Cure over fresh concrete**

Most curing procedures include spraying the fresh concrete surface with a curing agent immediately after the burlap drag or broom finish and as soon as the bleed water is no longer present on the surface (Figure 34). Curing may also be accomplished by placing plastic or wet burlap on the pavement surface and keeping it in place for three to seven days. If wet burlap is used, it is important that the burlap is kept saturated during the entire curing period.

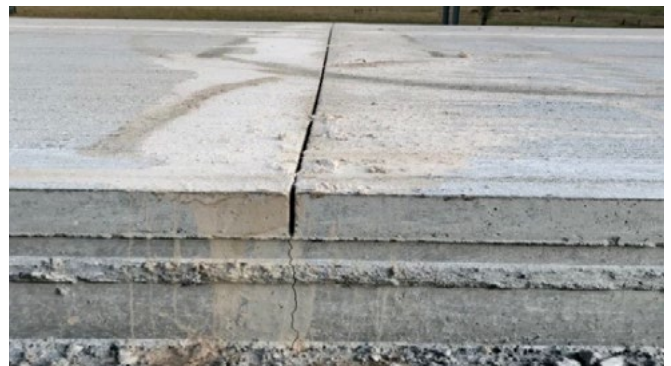
**Figure 35. Activated transverse joint**

Contraction joints can be established by saw cutting or tooling. Even though tooling is the simpler method, it requires skilled effort. Typically, saw cuts provide a smoother ride. Both saw cuts and tooling should be at a depth of at least  $\frac{1}{4}$  of slab thickness to achieve proper joint activation.

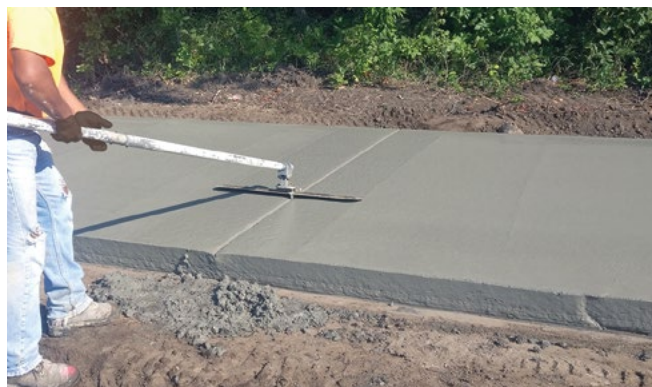
**Figure 37. Hand-tooled joints prior to saw operations**

Some contractors tool transverse contraction joints at long intervals prior to sawcutting to reduce the probability of an early random crack. The concern with this method is the extra care needed so that the formed joint does not make a depression in the surface and negatively impact trail smoothness (Figures 37 and 38).

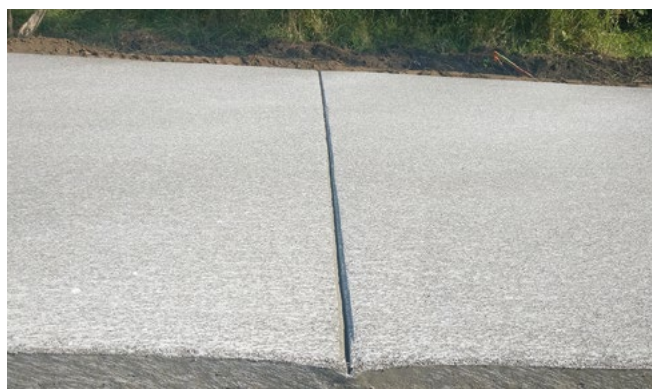
**Figure 38. Tooled transverse joint in fresh concrete**

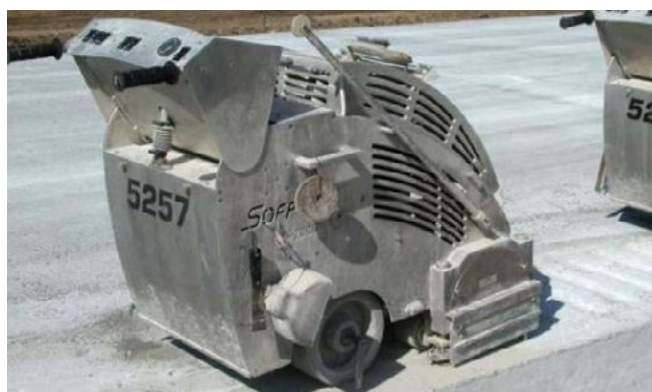
**Figure 39. Early-entry concrete saw**

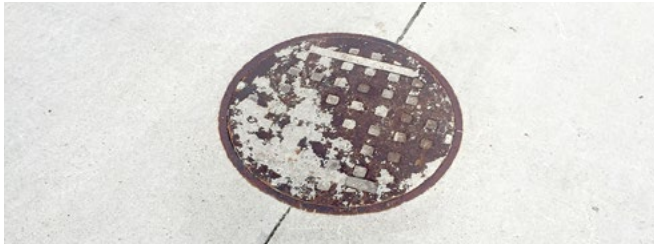
**Figure 40. Utility access casting—completely within trail pavement slab**

Trails may follow utility corridors or roadways where utilities are present. Utility access castings (manhole covers) are often in proximity to trail construction. Ideally, the trail paving would be designed with the casting outside the pavement. If this is unavoidable, then the trail should be designed so the casting is fully within the concrete slab (Figure 40). It is not desirable to locate the casting on the edge of the trail pavement (Figure 41).

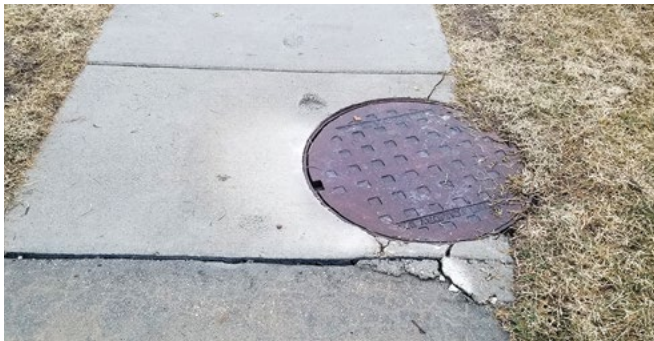
**Figure 41. Utility access casting—partially within trail pavement slab**

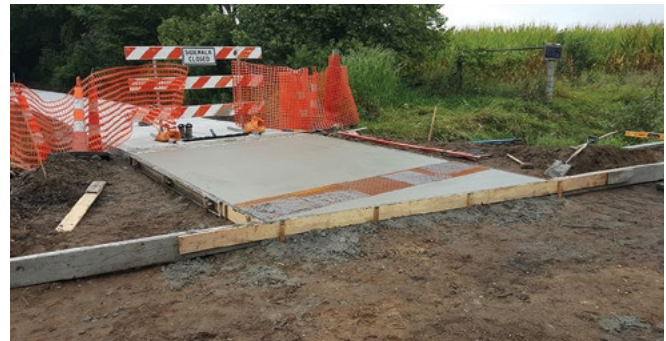
**Figure 43. ADA ramp in rural section**

Detectable warnings, truncated domes, and tactile warning strips refer to the same product that provides advance warning to persons who are visually impaired. The detectable warning must provide full coverage across the trail opening, except for the sloped flares (Figures 43 and 44). The location of the detectable warnings shall be where the ramp ends and the street begins. For urban sections, they are located at the back of the curb line. For rural applications, they are located at the edge of the shoulder. Detectable warnings must be installed per the manufacturer's recommendations, which can vary depending on the material type specified in the contract documents. If the material requires a concrete border away from a joint or edge for proper installation, it shall be 2 in. or less per the Public Right-of-Way Accessibility Guidelines (USAB 2011).

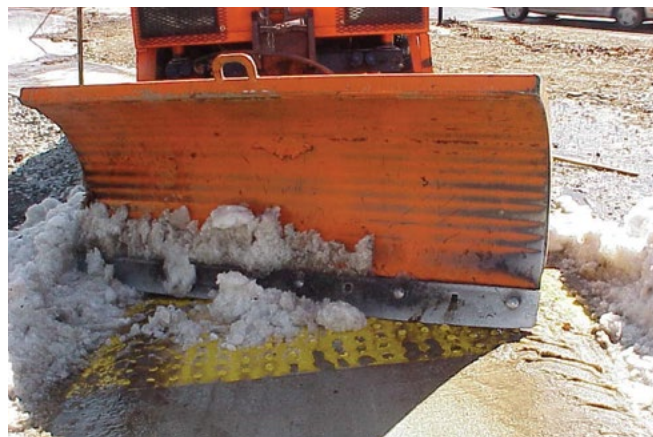
**Figure 45. Snow removal can cause damage to plastic domes**

Cast iron materials perform better in areas that require snow removal but are more difficult to cut and place if an irregular shape is needed. Composite material panels suffer from domes shearing off; however, they can be installed as replaceable panels with bolt-on connections. Figure 45 shows damage to truncated domes during snow removal.

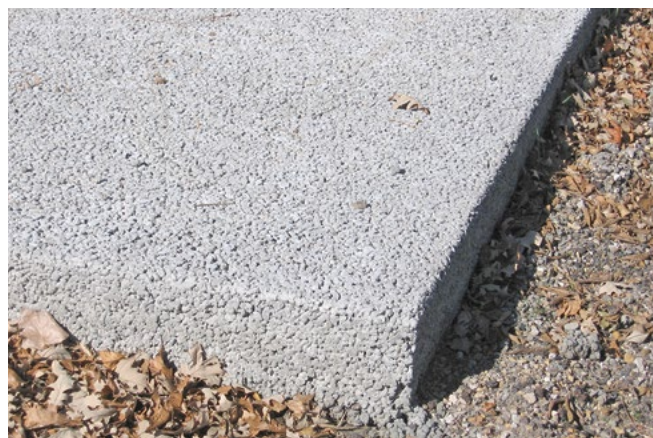
**Figure 46. Pervious concrete**

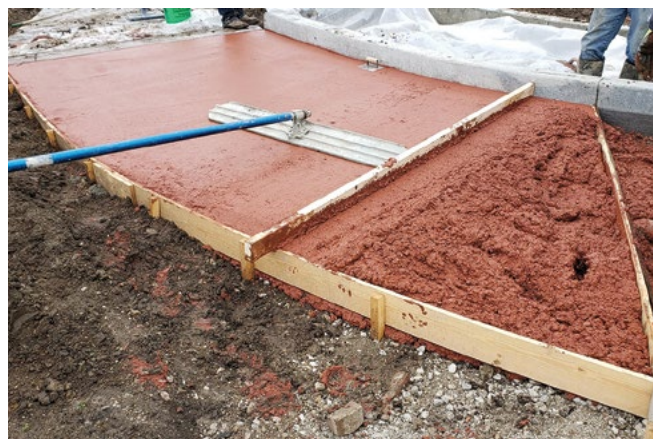
**Figure 47. Colored sidewalk**

Colored concrete is specified when an owner wants to bring attention to special areas for safety or aesthetic value (Figure 47). It can be used near crossings and transitional locations to focus user attention. It can also be used to blend the trail into the surroundings or create patterns.

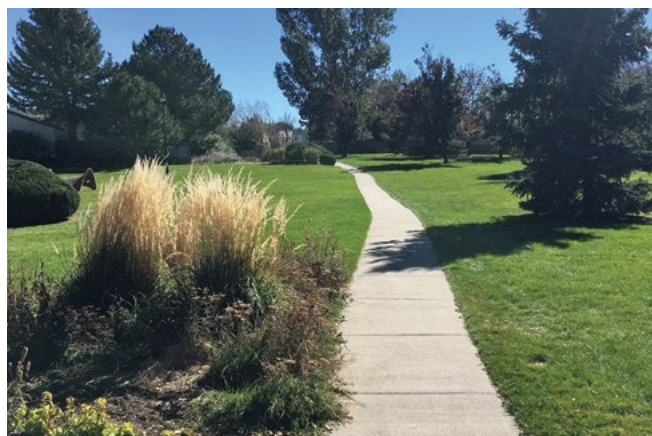
**Figure 49. Asphalt path was replaced by concrete 20 years ago**

In 1991, the HOA board of directors faced a decision on what to do with the asphalt trail system built by the subdivision developer. The trails were literally falling apart, shrinking in width, and in some places completely disintegrating. After considering the life-cycle costs of replacing the pavement, the board elected to systematically replace all the trails with concrete pavement over the next 8 years (Figure 49). The final project was completed in 1997. Other than replacing a panel or two due to tree root expansion, the HOA has not spent any money on maintaining the concrete trail system over the last 25 years, freeing up resources to spend in other areas.

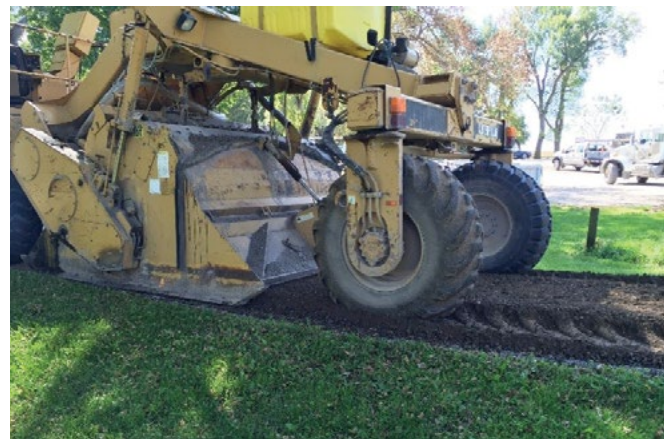
**Figure 50. Western Engineering Company reclaiming the existing asphalt trail**

Howrey Construction completed reconstruction of the 3.5 mi of trail around Swan Lake State Park in Carroll, Iowa. Scarification of the existing asphalt trail saved the Carroll County Conservation Board money in many ways. The existing pavement did not need to be removed and disposed of, saving time and money. It also served as a base once compacted, and no additional base material was needed. Western Engineering Company reclaimed the asphalt in 6 working days, and the entire project was paved over 14 working days during the fall of 2015 (Figures 50 and 51).

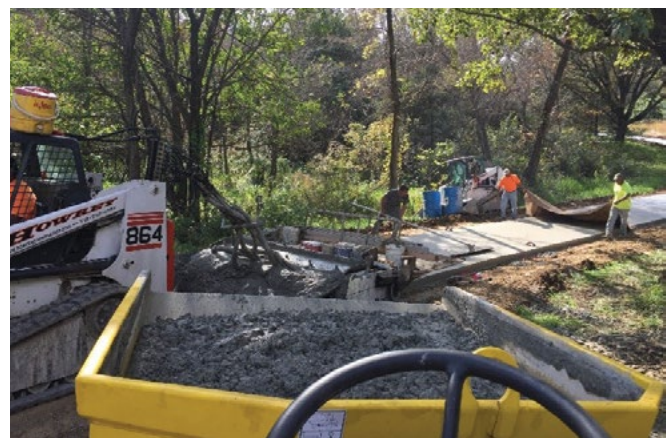
**Figure 51. Howrey Construction paving in October 2015**

Some construction challenges existed, including a crowded right of way with vegetation and steep grade changes. Construction access was also limited on the project. Some ready-mix concrete trucks had to park as far away as half a mile from the slipform paver. Concrete buggies and dumpers were utilized for long-haul distances.

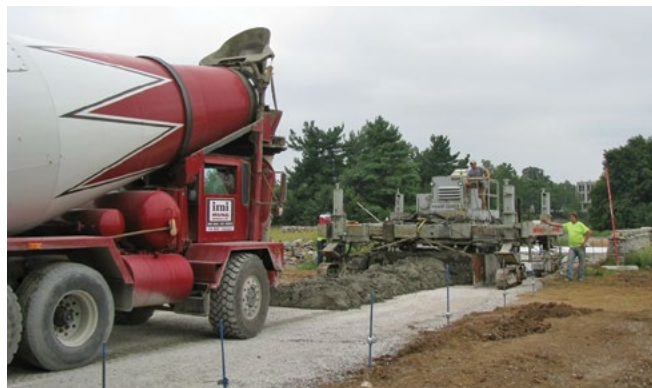
**Figure 52. Slipform paving was used for part of Legacy Trail**

The Legacy Trail is a 12 mi multiuse path stretching from downtown Lexington, Kentucky, to the Kentucky Horse Park. It runs north to south through green spaces, neighborhoods, and parks. About 8 mi of the trail is off-road, and it is all paved. A section of the trail was placed with a slipform paver (Figure 52). Limestone pillars mark each end of the trail. An 8 mi section of the trail is conventional concrete (Figure 53), and a 4 mi section is pervious concrete.

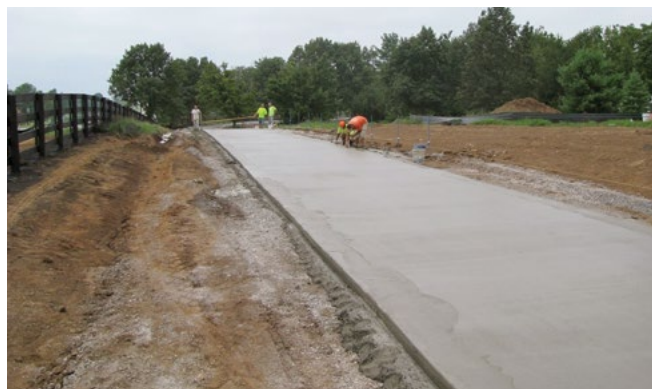
**Figure 53. 8 mi of the trail were built with conventional concrete**

The park itself has many concrete paths and trails. About 3 mi of conventional path was 6 in. thick 4,000 psi concrete, and 5 mi of the path was 4.5 in. thick concrete on a 4 in. thick dense-graded aggregate base. No fibers were used. The pervious path was 6 in. thick and done with a riding triple-roller screed.

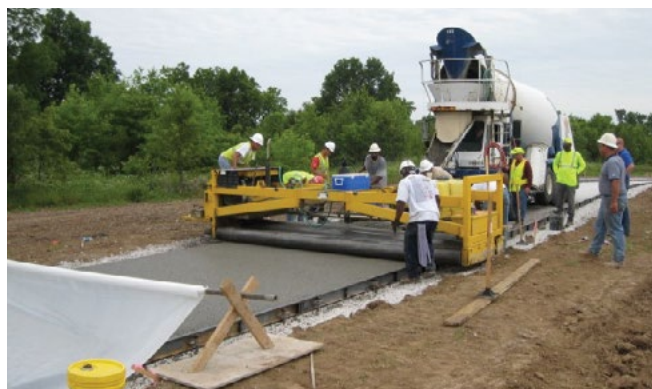
**Figure 54. Pervious concrete trail south of Kentucky Horse Park**

The trail enters the Kentucky Horse Park just north of I-64. The pervious section is just south of the Kentucky Horse Park (Figure 54). The Kentucky Horse Park is a 1,200 ac working farm with museums and horse shows.

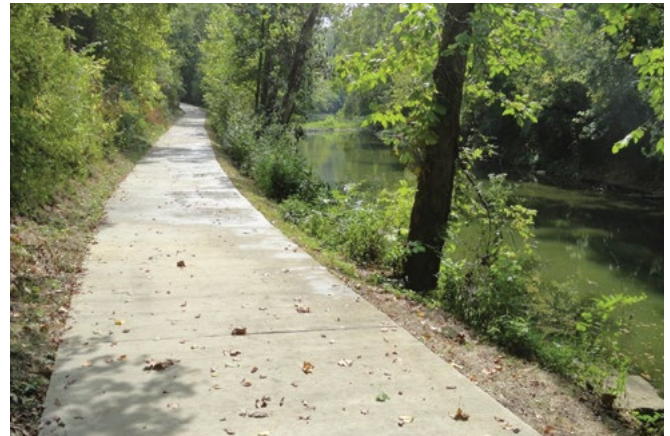
**Figure 56. Trail is in flood plain, passing along water bodies, woodland, and grass**

The Parklands of Floyds Fork project was one of the largest park initiatives in the United States in 2015 (see [www.theparklands.org](http://www.theparklands.org)). The project team chose concrete for approximately 8 mi of the new multipurpose trail. These 8 mi are largely in a flood plain and weave through woods, by streams, and through grass fields (Figure 56).

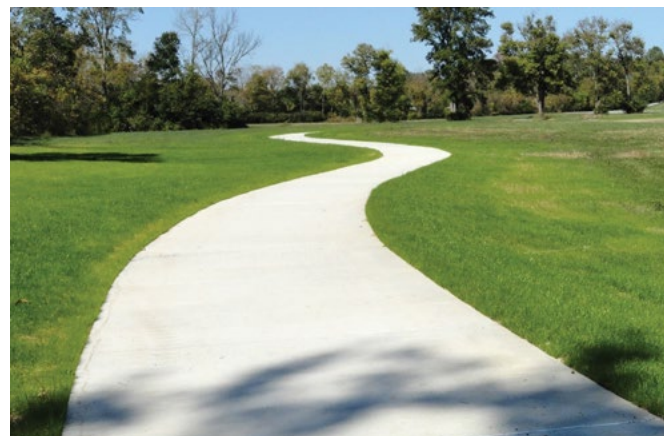
**Figure 57. Fiber-reinforced concrete was used for the trail**

The design of 6 in. thick concrete with turndown edges (8 in. depth) was used to address flooding concerns and to accommodate lightweight maintenance trucks. The mix was 4,000 psi, was fiber reinforced, and had a high-range water reducer (Figure 57).

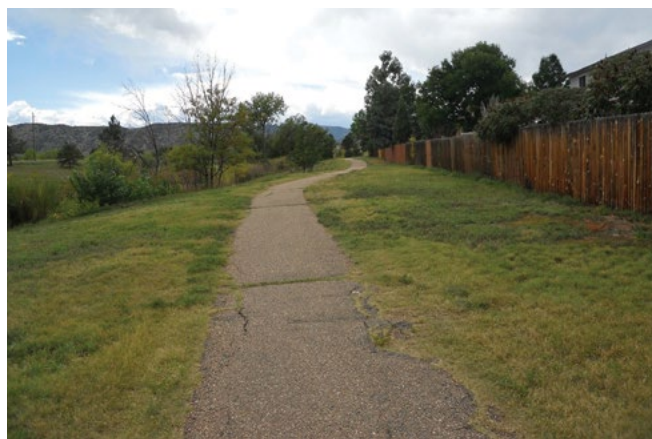
**Figure 58. Wingate South Park trail before construction**

The Foothills Park & Recreation District is a special district formed in 1959 to focus on parks and recreational facilities in Jefferson County, Colorado. The district maintains several recreation centers, trails, and golf courses throughout Jefferson County. The asphalt trail at Wingate South Park in Littleton, Colorado, had reached the end of its service life, and the district was considering removing and replacing the trail with asphalt (Figure 58). This approach would have required removal of a large amount of material in an area with few access points.

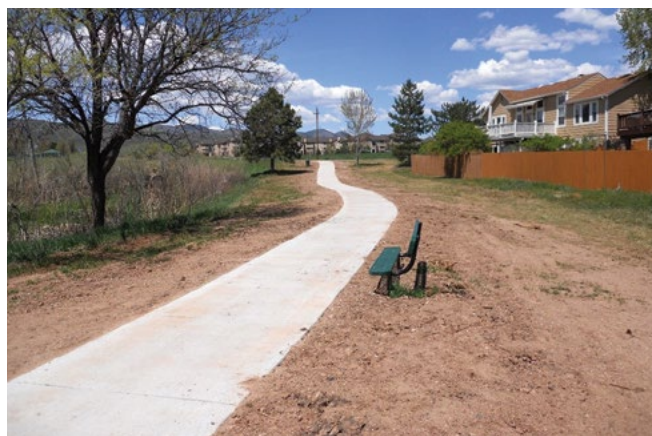
**Figure 59. Wingate South Park trail after construction**

Trail users at the Wingate South Park are now greeted by a beautiful, bright, and safe concrete trail running through the scenic open space (Figure 59). In addition, the district not only saved time and money over the asphalt reconstruction alternative, but they will also enjoy years of low maintenance, freeing up money to spend on other important recreation projects.

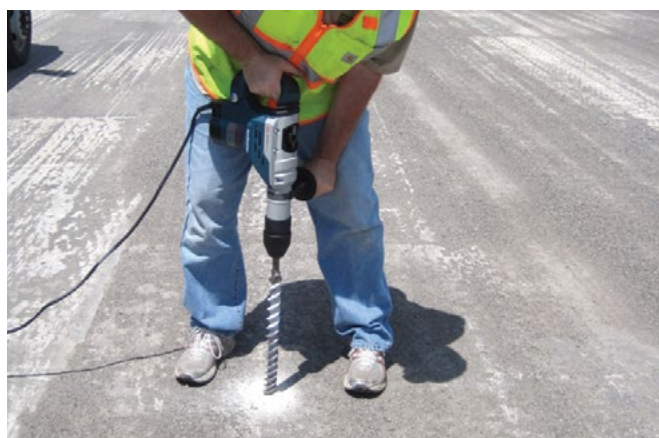
**Figure 61. Hammer drill being used to check pavement thickness**

A uniform support system for the concrete pavement is critical to the long-term performance of the trail. Therefore, it is important to have a good understanding of the existing trail pavement structure prior to considering a concrete overlay.

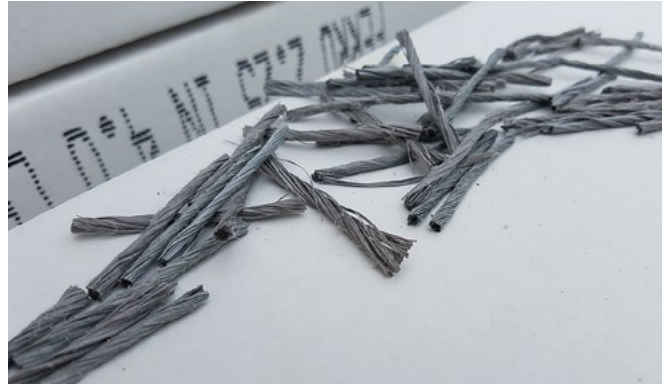
Figure 62. Synthetic macrofibers

Steel and synthetic fibers are the most common types of fiber used in paving. Synthetic fibers are polymeric and may be monofilament or multifilament (Figure 62). Steel fibers can have circular, semicircular, or rectangular cross sections, and the individual fibers can be straight, hooked-end (crimped), enlarged-end, or deformed. Synthetic fibers are easier to handle, are less prone to balling and clumping, and have no rust issues like steel fibers. Steel fibers can also settle at the bottom of pavement if not properly mixed because of their higher density than synthetic fibers. Steel fibers are also typically more costly than synthetic fibers.

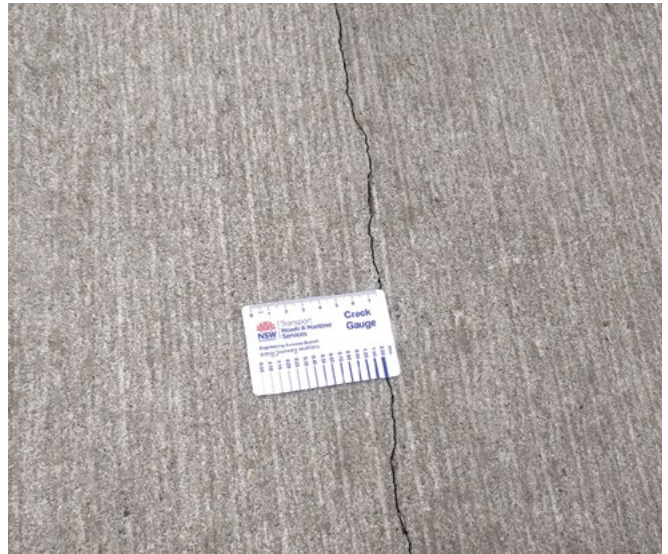
Figure 63. Concrete pavement without fibers and with noticeable longitudinal crack

The images in Figures 63 and 64 are of the same concrete pavement. Figure 63 shows a section of the pavement without fibers where a noticeable crack has formed. Figure 64 shows a test area with 4 lb/yd<sup>3</sup> of synthetic fibers incorporated into the mix, and only a hairline crack has formed in this area.

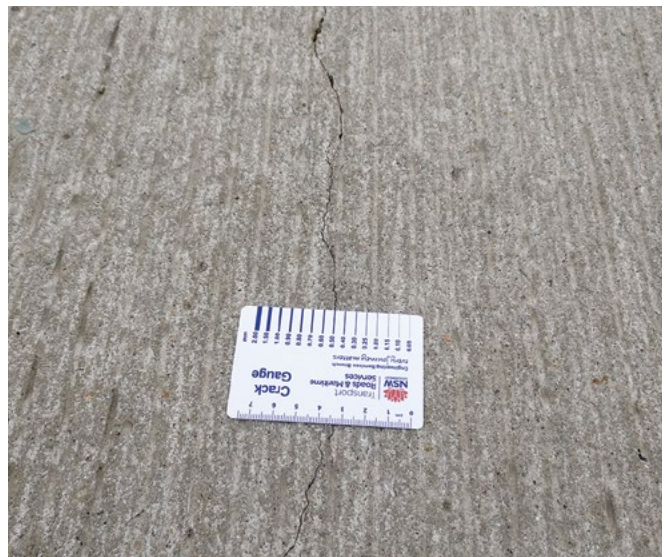
Figure 64. Concrete pavement with fibers and hairline crack
