CALL FOR PARTICIPANTS

A Laser Scanning Interlaboratory Study on Selected ACI 117 Tolerance Compliance Verification

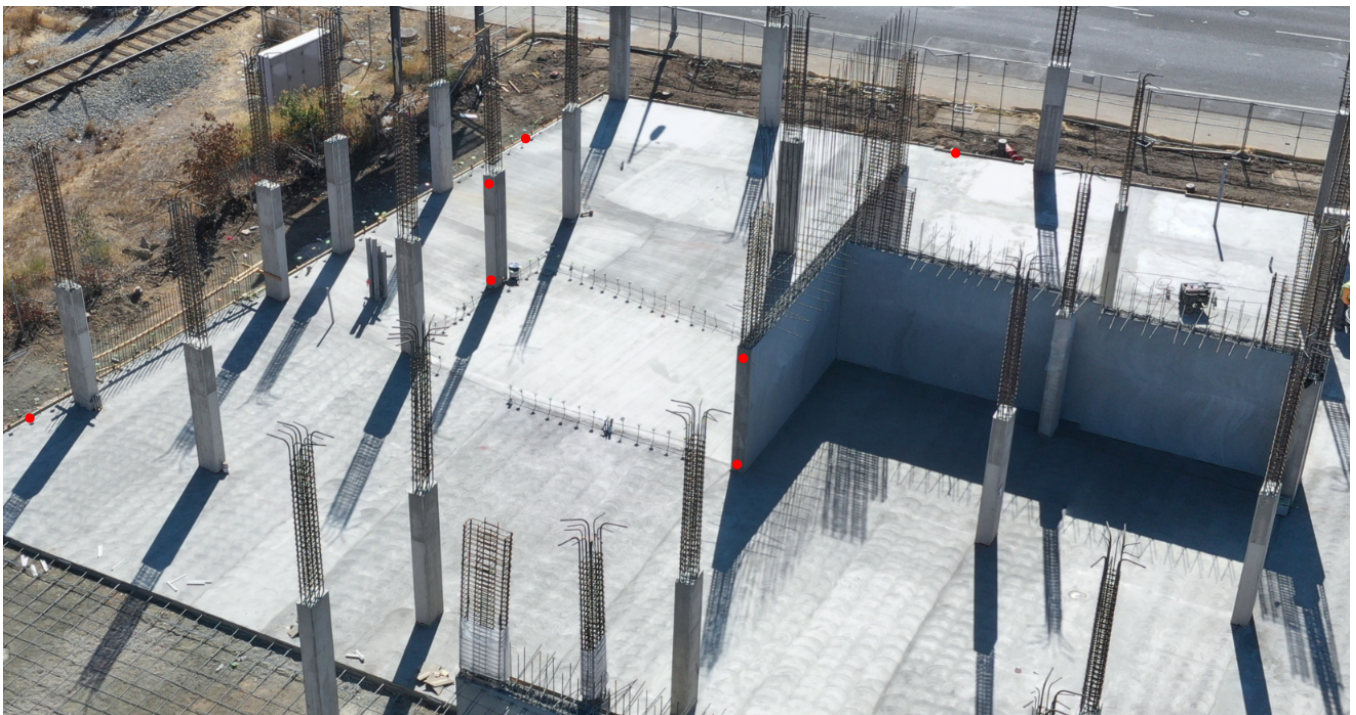
Step 1: Mark the test areas (10 points on slab edges, bottom of columns/walls, top of columns/walls, openings, example as shown on the photo below);
